NASA TN D-6721

APOLLO EXPERIENCE REPORT - WINDOW CONTAMINATION

by L. J. Leger and R. W. Bricker

Manned Spacecraft Center

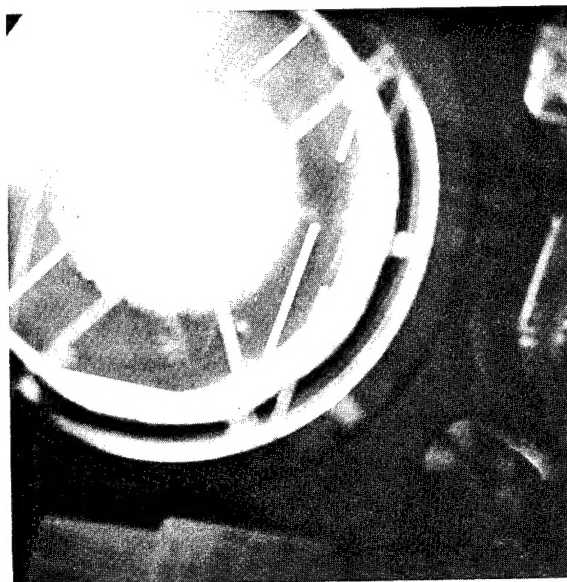
Soon after earth-orbital insertion, a film appeared on surfaces 2 and 3 of the hatch and side windows of the Apollo 7 and 8 command modules. This contamination continued to accumulate during flight and resulted in a heavy film in some locations and droplet formation in other locations. A photograph, taken with a camera focused on the hatch window during the Apollo 7 mission, is shown in figure 7. During the night pass of the spacecraft in earth orbit and during other similar cold-window conditions, the contamination seemed to crystallize and become opaque, particularly on the hatch window.

Figure 7. - Apollo 7 inflight hatch-window contamination.

In general, however, the most serious contamination was on surfaces 2 and 3 of the hatch and side windows on the Apollo 7 and 8 missions. Crewmembers from these two missions felt that, if the contaminants on these surfaces could be reduced or eliminated, the minor amount of contamination on the outer surfaces was not sufficiently serious to interfere with visual observations and photography.

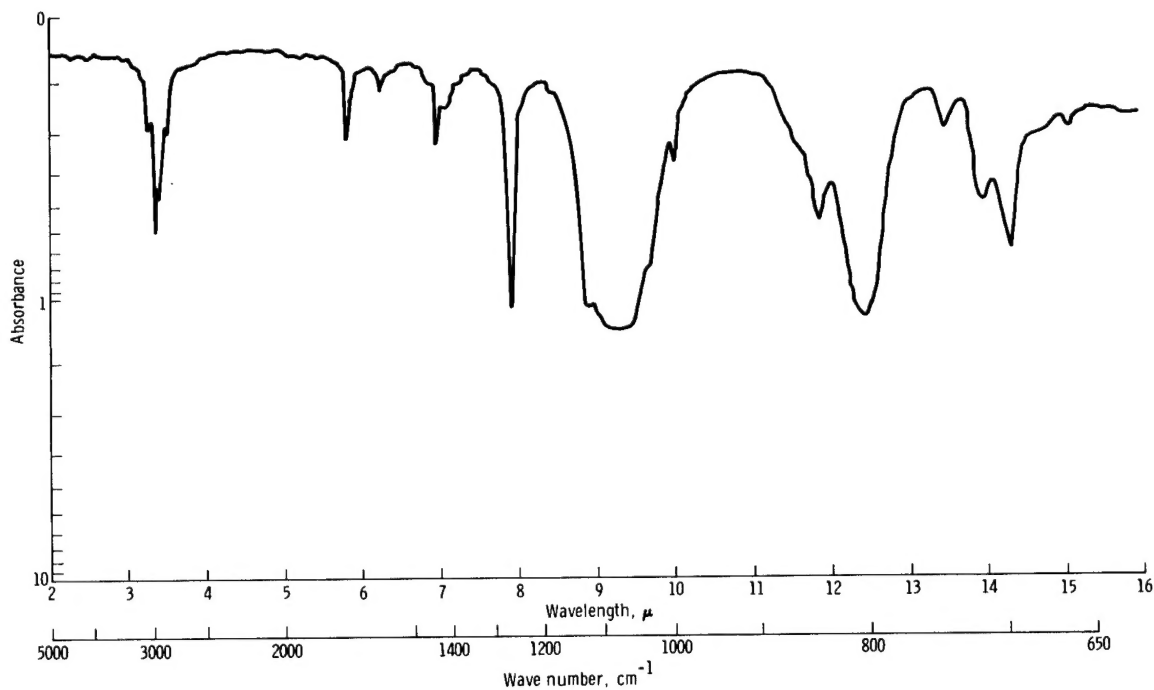
The infrared spectra of contamination collected from surfaces 2 and 3 on the windows of the Apollo 7 and 8 spacecraft were typical of organosilicon high-molecular-weight compounds. A representative spectrum of this contamination is shown in figure 8; the spectrum contains absorption bands common to the methyl-phenyl silicone structure. The same type of contamination was identified on the window of an Apollo CM (2TV-1) that was used for thermal-vacuum testing at the NASA Manned Spacecraft Center.

Figure 8. - Typical infrared spectrum of contaminations from surfaces 2 and 3 on the Apollo 7 and 8 CM's.

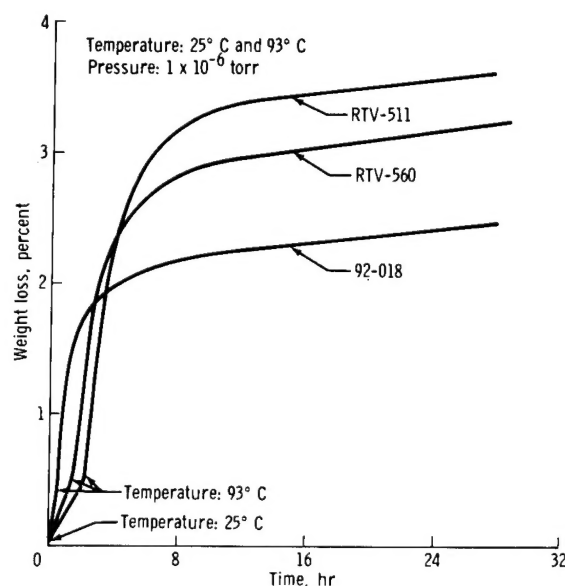
Isothermal-vacuum weight loss of the problem materials was determined by use of a continuous-recording vacuum balance. The vacuum weight loss of these materials at 93° C is shown in figure 9. This temperature was the maximum temperature expected in flight for materials that were used in the window area. Samples of all three materials had large initial weight-loss rates (approximately 1.25 percent/hr) that subsequently, after 15 hours, decreased to a much smaller rate (approximately 0.01 percent/hr).

Figure 9. - Vacuum weight loss of window materials that caused contamination on surfaces 2 and 3.

Because the weight-loss rates for the problem materials were small after exposure to vacuum at elevated temperatures, an apparent solution to the silicone-outgassing problem was to bake the manufactured parts in a vacuum before installation in the spacecraft. This process was used with success in reducing the Gemini window contamination (ref. 3). In applying a vacuum bake, it is desirable to use as high a temperature as possible in the thermal-vacuum exposure. However, at high temperatures (approximately 250° C), polymer degradation is possible. Therefore, a temperature of 205° C was chosen as the maximum allowed in the vacuum bake. At this temperature, the weight loss levels off (fig. 10). This condition indicates no major thermally induced polymer degradation has occurred.

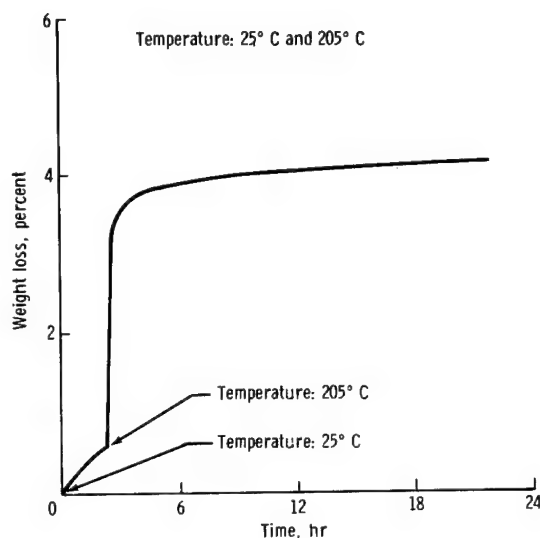
Figure 10.- Vacuum weight loss of RTV-560 at temperatures used in the manufacturing process at 1×10^{-6} torr.

Further considerations of the corrective action indicated that the vacuum bake should be conducted at low pressures and for long periods of time. However, because of limited chamber availability, a maximum pressure of 1×10^{-1} torr was allowed, and an exposure time of 1.72×10^5 seconds (48 hours), divided into two 8.64×10^4 -second (24 hours) steps, was used. The weight loss during and after exposure of the materials

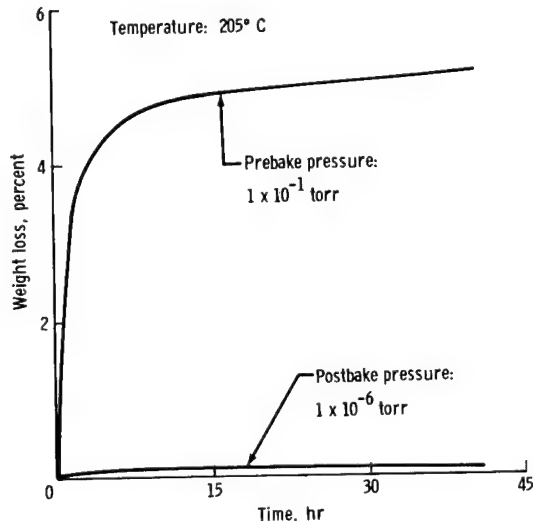
Figure 11.- Vacuum weight loss of RTV-560 for manufacturing cycle simulation.

to a vacuum of 1×10^{-1} torr at 205°C is shown in figure 11. Because the total weight loss after the vacuum bake is small (approximately 0.08 percent) and because only a small amount (approximately 0.008 percent) of this weight loss is condensable material at 25°C , a vacuum bake at the conditions selected (1×10^{-1} torr for two 8.64×10^4 -second periods) was considered adequate to prevent contamination of the spacecraft windows.

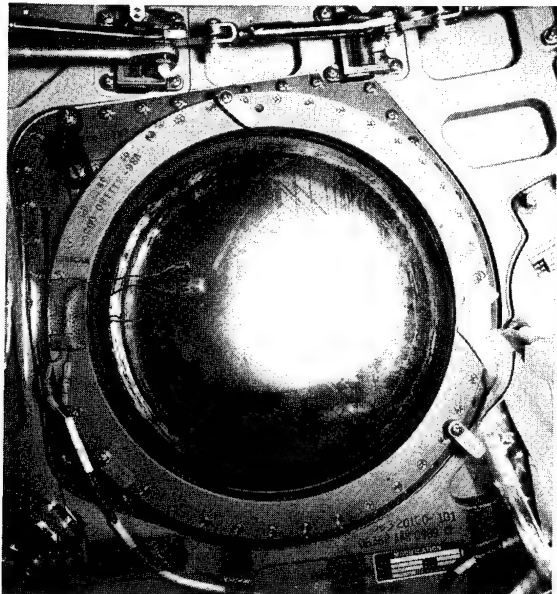
During the maximum heating conditions of the test, the maximum temperature that was measured for the nonmetallic materials was 87°C , whereas the temperature of surface 2 of the hatch window attained -20°C in the cold conditions of the test. A small amount of contamination was noticed during a short portion of the first cold-soak period of the hatch test. The contamination disappeared early in the first heating cycle and did not reappear. This phenomenon had been noticed in earlier tests and was attributed to water vapor trapped between the heat shield and the pressure-vessel structure. Post-test infrared analysis of the hatch-window surfaces indicated no detectable contamination.

Figure 12. - Hatch window of 2TV-1.

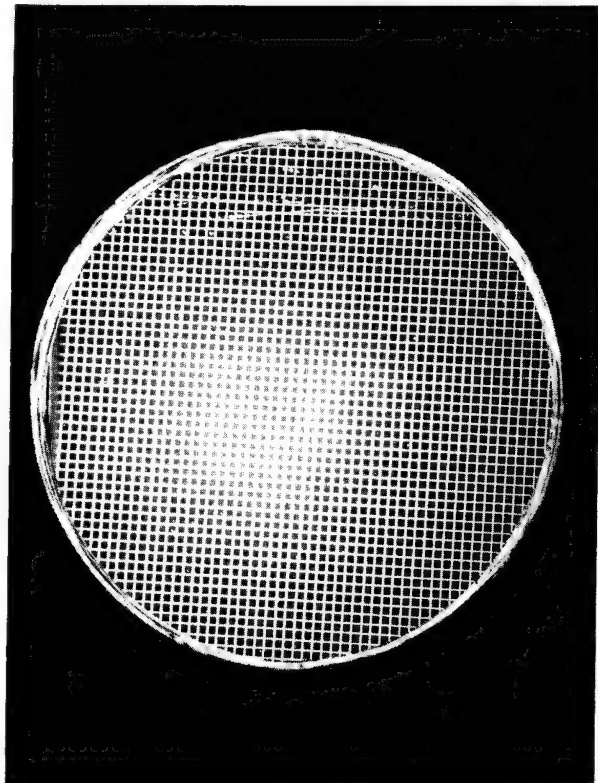
Crewmember reports and the postflight examination did not indicate any contamination problems on the windows made of baked parts. The rendezvous windows, however, were contaminated slightly. This problem did not cause major concern because subsequent flights would involve the use of baked parts for all windows. A photograph (fig. 12) of the hatch window of 2TV-1 (a test vehicle that revealed window contamination similar to that found on the Apollo 6, 7, and 8 flights) is compared with a grid photograph (fig. 13) of the Apollo 9 hatch window after recovery. In figure 13, the grid, which is behind the window assembly, is shown clearly. Conversely, large amounts of contamination over the entire window are shown in figure 12. In this photograph, condensation of the contamination had accumulated to such an extent that droplet streaks were detectable. Although the photographs were not taken under the same conditions (the 2TV-1 photograph had no grid), they both indicate that a significant improvement was obtained by the use of vacuum-baked parts.

Figure 13. - Apollo 9 hatch window.
